Blygold®

Introduction

Why does a cooling system lose efficiency over time?

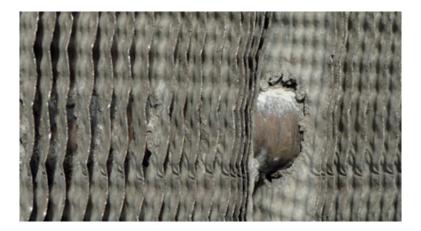
Galvanic corrosion

The metals in a heat exchanger are exposed to large amounts of airborne contaminants, causing accelerated deterioration. However, the biggest challenge is the combination of copper and aluminium in the heat exchanger. In the presence of moisture and dirt, aluminium will corrode even faster in the presence of copper. This is because aluminium is less "noble" (and more reactive) than copper, creating a potential risk of *galvanic corrosion*. This is a common problem in heat exchangers and has a very negative impact on heat transfer efficiency. Roughly 70% of the total heat transfer takes place through the aluminium fins, but this heat must first be transferred from the copper tubes into the aluminium. Any deterioration in the connection between aluminium and copper leads to a proportionate decrease in heat transfer.
